Baler interior was rescued from wear.

ID: 9783

Industry: *Food & Drink*
 Application: *TCC-Tanks and Chemical Containment Areas*
 Substrate: *Carbon steel*
 Products: *Belzona 1121 (Super XL-Metal)*

Customer Location: *Brantford*
 Application Date: *March 2025*

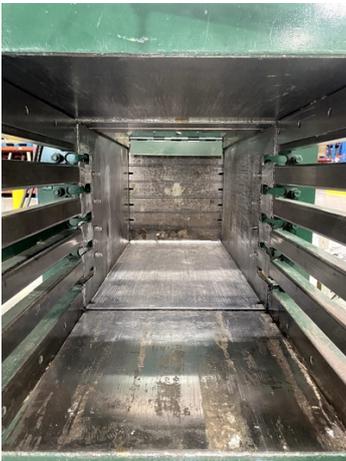
The lining of the baler was experiencing wear due to ramming of the loader. Plates could not be welded to both sides due to the thickness requirements. Belzona was consulted, we gave various options and customer picked that of rebuilding with a paste grade product.

Baler lining after power tool cleaning before application of Belzona 1121.

Power tools were used to clean the surface and create the required profile. Belzona 1121 was mixed and applied, then smoothed to give a more uniform application for ease of ramming of the loader. Equipment was put to test and customer was satisfied with the result.

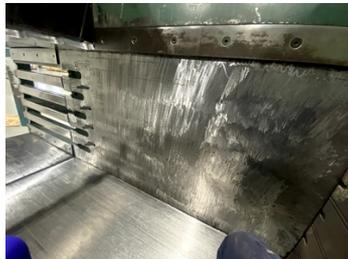
Side view of cleaning.

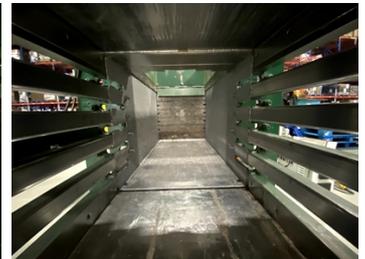
Both sides after application.
