Belzona Solutions for Rubber Balloon Crack Repair

ID: 9784

Industry: Marine
Application: SOS-Ships and Offshore Structures

Customer Location: ABU DHABI, UNITED ARAB EMIRATES
Application Date: January 2020

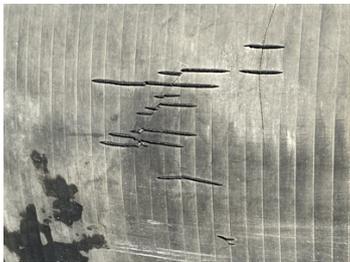
Significant cracking in their floating rubber balloons, mainly caused by dredging operations in the sea.
