Belzona repairs and strengthens severe through wall sliding abrasion to ash pipework at an Energy Recovery Plant

ID: 9785

Industry: Power
Application: VPF-Valves, Pipes and Fittings
Substrate: Stainless-steel
Products: Belzona 1511 (Super HT-Metal), Belzona 1983 (SuperWrap II), Belzona 9111 (Cleaner Degreaser)

Customer Location: Oxfordshire
Application Date: December 2024

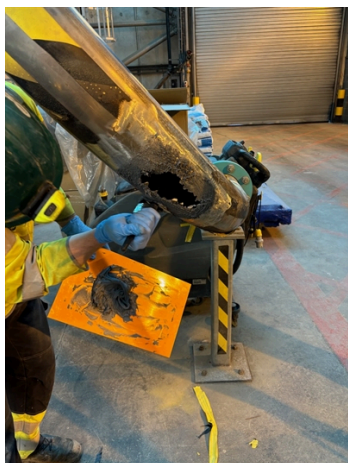
Pipe showing the large hole caused by sliding abrasion. Photo shows the pipe after surface preparation and starting to apply Belzona 1511 Super High temperature metal for the patch to be bonded onto.

A stainless steel patch was cut from a similar sized spare pipe to be bonded over the through wall areas and this was prepared on both sides. The plate was then bonded over the holed elbow with Belzona 1511 Super High temperature metal and held in place with strap clamps until the Belzona 1511 had cured sufficiently. The straps were removed and Belzona 1983 SuperWrap II was applied in several layers to strengthen the thin pipe on the elbow and either side of the patch repair.

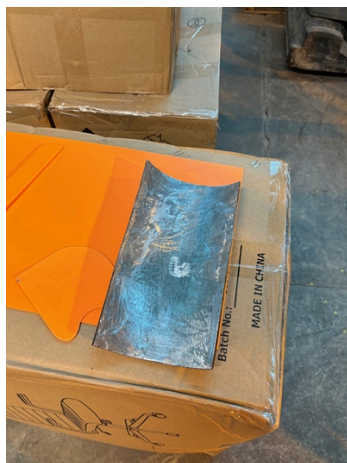
The Steel patch after surface preparation both sides, which is going to be bonded over the large elbow hole.

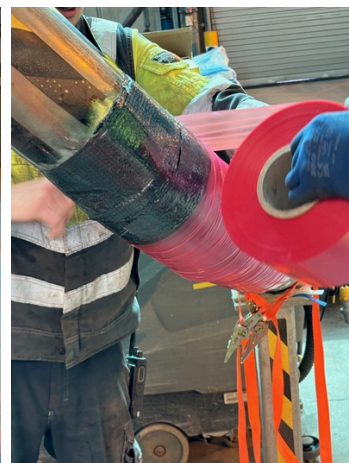
Belzona 1983 SuperWrap II has now been applied over the pipe elbow, covering the new patch and 200mm each side of this to give some structural Integrity back to the chute. Release film is being applied tightly to consolidate the application.
