# Belzona repairs and strengthens severe through wall sliding abrasion to ash pipework at an Energy Recovery Plant

ID: 9785

Industry: Power  
Application: VPF-Valves, Pipes and Fittings  
Substrate: Stainless-steel  
Products: Belzona 1511 (Super HT-Metal), Belzona 1983 (SuperWrap II), Belzona 9111 (Cleaner Degreaser)

Customer Location: Oxfordshire  
Application Date: December 2024

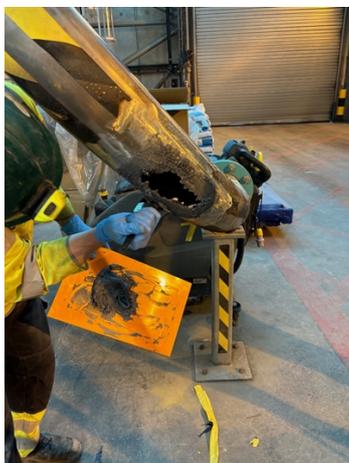
The customer treats 378,000 tonnes of non-recyclable waste each year and diverts at least 95% of the County's residual municipal waste away from landfill. During this process they generate enough electricity to power the equivalent of 80,716 homes. Non-recyclable waste is burned and the energy from combustion is re-used through turbines creating electricity. The ash left from the burning process falls down stainless steel pipe chutes and causes severe sliding abrasion and through wall problems in the pipework, especially on the bends.

Pipe showing the large hole caused by sliding abrasion. Photo shows the pipe after surface preparation and starting to apply Belzona 1511 Super High temperature metal for the patch to be bonded onto.

A stainless steel patch was cut from a similar sized spare pipe to be bonded over the through wall areas and this was prepared on both sides. The plate was then bonded over the holed elbow with Belzona 1511 Super High temperature metal and held in place with strap clamps until the Belzona 1511 had cured sufficiently. The straps were removed and Belzona 1983 SuperWrap II was applied in several layers to strengthen the thin pipe on the elbow and either side of the patch repair.

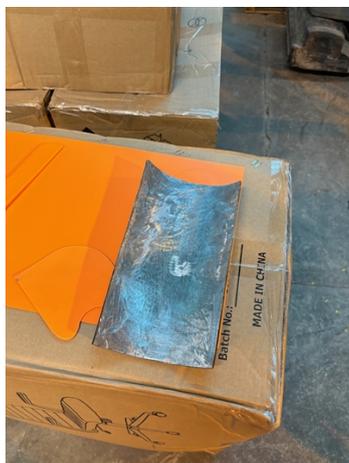
The Steel patch after surface preparation both sides, which is going to be bonded over the large elbow hole.

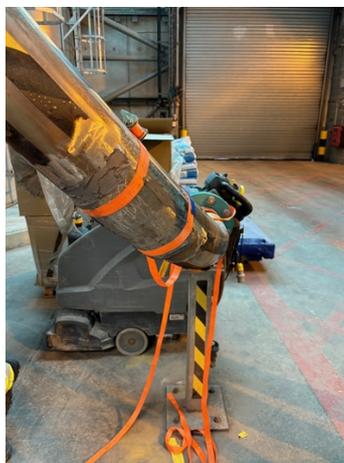
The steel patch now bonded into place over the hole and clamped with two strap clamps.

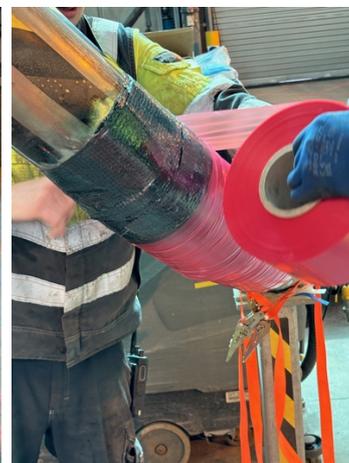
Belzona 1983 SuperWrap II has now been applied over the pipe elbow, covering the new patch and 200mm each side of this to give some structural Integrity back to the chute. Release film is being applied tightly to consolidate the application.
