Power Plant Hydrocyclone repaired with Belzona

ID: 9788

Industry: *Power*
Application: *TCC-Tanks and Chemical Containment Areas*
Substrate: *Carbon steel*
Products: *Belzona 1811 (Ceramic Carbide)*

Customer Location: *Trimble County*
Application Date: *July 2010*

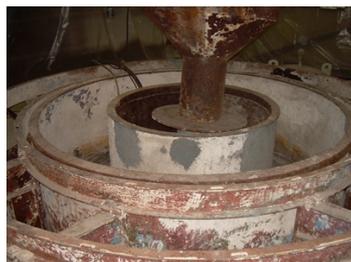
Severe wear due to abrasion caused this hydrocyclone to lose its efficiency.

A well used Hydrocyclone

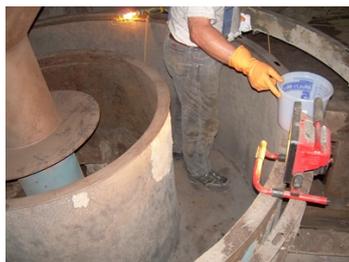
Applying Belzona 1811 (Ceramic Carbide)

Unit was grit blasted to SSPC SP 10 then washed down with MEK. Belzona 1811 (Ceramic Carbide) was mixed and applied according to the products Instructions for Use.

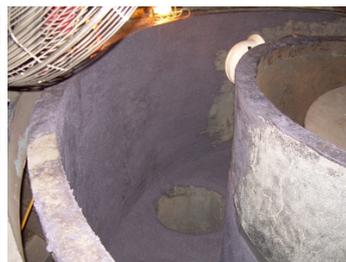
Belzona 1811 (Ceramic Carbide)

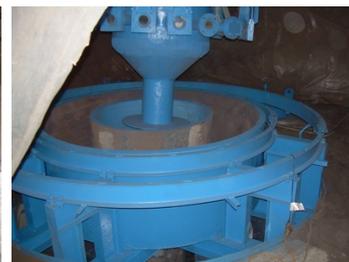
Finished application and fresh paint
