# Belzona 4181 Repairs Secondary Containment Systems in Sweden

Customer Location: Torshälla, Sweden

Application: TCC-Tanks and Chemical Containment Areas

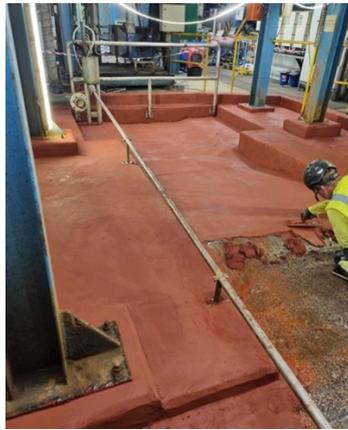
The highly corrosive environment (hydrofluoric, nitric and sulfuric acid) of this secondary containment area below a picking line was suffering extreme erosion on the 550m<sup>2</sup> of concrete and its failing GAP-coating.

Extent of the chemical attack.

We started by water-jetting the old concrete and then we recast the old gutters and channels, we then raised the containment edge. Followed by the conditioning of Belzona 4911 to the areas to be coated. And then finished of by applying Belzona 4181.

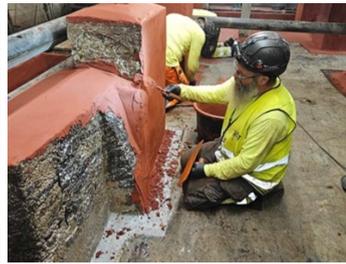
Belzona 4181 rebuilding the damage.
