BELZONA MEMBRANE TO THE RESCUE

Industry: *Buildings & Structures*
Application: *RPA-Roof Problem Areas*
Substrate: *Felt*
Products: ** Belzona 3131 (WG Membrane),*

Customer Location: *Hotel, Edinburgh, Scotland*
Application Date: *December 2007*

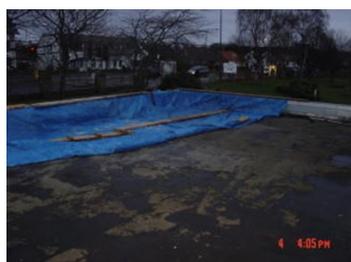
- * View of the "tired" and uncoated roof ,
- * Area where water was penetrating ,
- * Completed gutter, the main problem area ,
- * Completed Belzona application ,

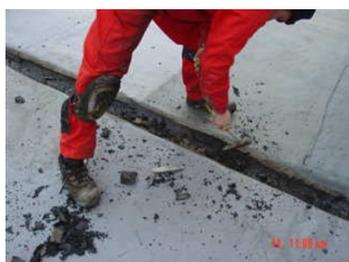
Water penetrating gutter joints due to weight of water on the joints. Owner required immediate repairs to prevent disruption to business.
