# BELZONA MEMBRANE TO THE RESCUE

Industry: *Buildings & Structures*  
Application: *RPA-Roof Problem Areas*  
Substrate: *Felt*  
Products: *\* Belzona 3131 (WG Membrane),*

Customer Location: *Hotel, Edinburgh, Scotland*  
Application Date: *December 2007*

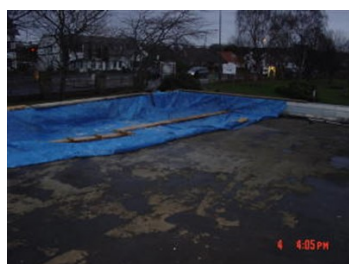
*Water penetrating gutter joints due to weight of water on the joints. Owner required immediate repairs to prevent disruption to business.*

- \* View of the "tired" and uncoated roof ,
- \* Area where water was penetrating ,
- \* Completed gutter, the main problem area ,
- \* Completed Belzona application ,

The application was carried out in accordance with Belzona Know-How System Leaflet RPA-1 and RPA-6.
