BELZONA MEMBRANE TO THE RESCUE

ID: 979

Industry: *Buildings & Structures*
Application: *RPA-Roof Problem Areas*
Substrate: *Felt*
Products: ** Belzona 3131 (WG Membrane) ,*

Customer Location: *Hotel, Edinburgh, Scotland*
Application Date: *December 2007*

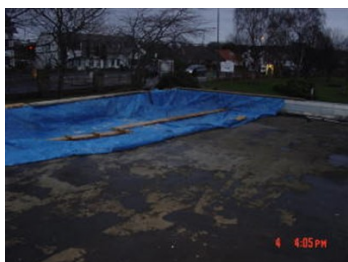
- * View of the "tired" and uncoated roof ,
- * Area where water was penetrating ,
- * Completed gutter, the main problem area ,
- * Completed Belzona application ,

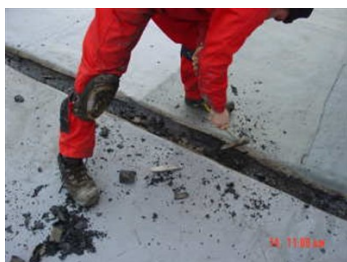
Water penetrating gutter joints due to weight of water on the joints. Owner required immediate repairs to prevent disruption to business.
