# Belzona 4111 Provides a Quick Fix and Repair on Dips in a Steel Tank Roof

ID: 9791

Application: TCC-Tanks and Chemical Containment Areas

Application Date: March 2025

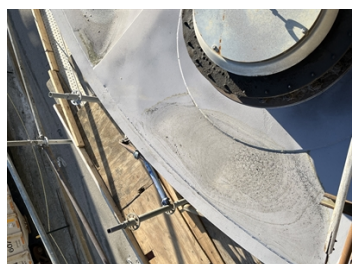
*This asphalt tank roof was experiencing a few low areas where water would collect for long periods of time after rainfall. Previous installation of the roof structure renovation was struggling and created the concave areas. The pooled water threatened damage to the areas in question.*

You can see the pooled water in the dip areas on the tank roof needing to be addressed.

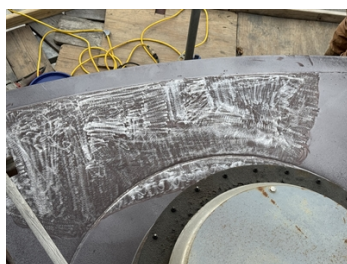
A diamond wheel grinder was used to achieve the appropriate profile on the low areas on the steel. The area was extended beyond the low points to be able to feather the product out and recreate a slope.

A diamond wheel was used on a handheld grinder to achieve a roughened surface on the steel. We initially discussed sandblasting but this was quicker and surprisingly was a low spark option. Belzona 4111 was the chosen product and small/large trowels were used to smooth it into place.

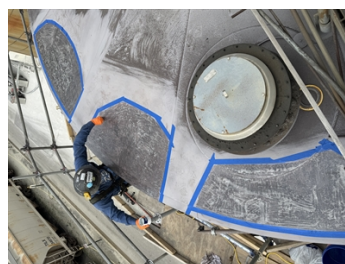
Belzona 4911 Conditioner is seen here be applied on top of the prepared steel.

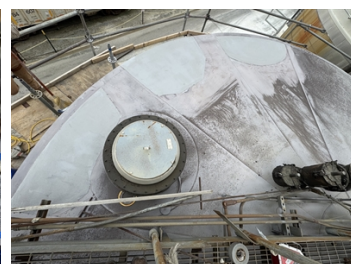
Belzona 4111 was trialed over the prepared areas and is set for future protection.

Our client needed a "bulk" product to fill these dipped areas on the tank roof. These tanks go down every two years and they had a week to be able to address it quickly in order to power back on. The tank did contain asphalt and the temperature would reach about 146 degrees dry heat so we were able to select 4111 for this application. This product covered the dips well and provided a cost effective option for this client.
