# Belzona 4111 Provides a Quick Fix and Repair on Dips in a Steel Tank Roof

ID: 9791

Application: TCC-Tanks and Chemical Containment Areas

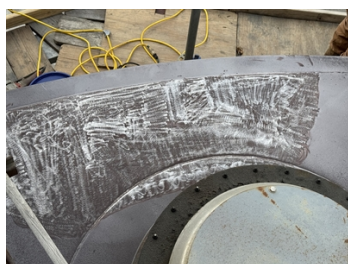
A diamond wheel grinder was used to achieve the appropriate profile on the low areas on the steel. The area was extended beyond the low points to be able to feather the product out and recreate a slope.

A diamond wheel was used on a handheld grinder to achieve a roughened surface on the steel. We initially discussed sandblasting but this was quicker and surprisingly was a low spark option. Belzona 4111 was the chosen product and small/large trowels were used to smooth it into place.

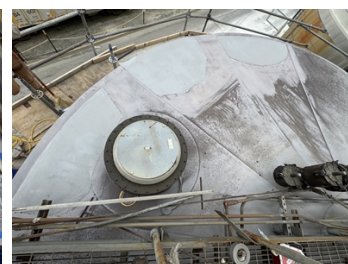
Belzona 4111 was trialed over the prepared areas and is set for future protection.
