# Tank Protection at an Oil Terminal with Belzona

ID: 9792

Application: TCC-Tanks and Chemical Containment Areas

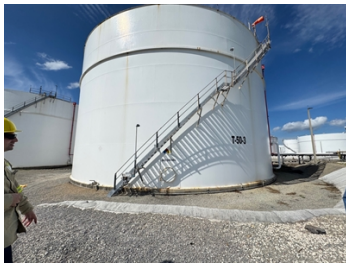
Tank T-50-3 at a biodiesel terminal. Water ingress was identified around the tank base, causing localized corrosion and posing a risk to structural integrity.

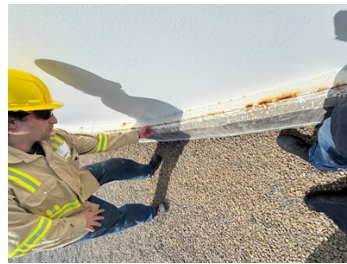
During the initial inspection, rust was observed at the junction between the tank ring and the concrete base — a clear indicator of moisture infiltration.

The application began with sandblasting to remove corrosion and contaminants, creating the ideal surface profile. Belzona 3921 was applied as a conditioner, followed by a first layer of Belzona 3111, reinforced with Belzona 9311 sheet. A second layer of 3111 sealed the system.

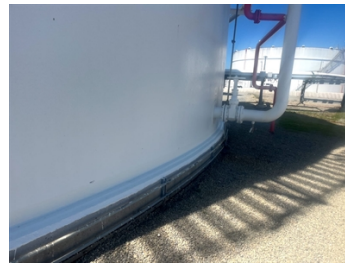
Belzona sealing system being applied. The first layer of Belzona 3111 is reinforced to ensure both mechanical strength and flexibility.

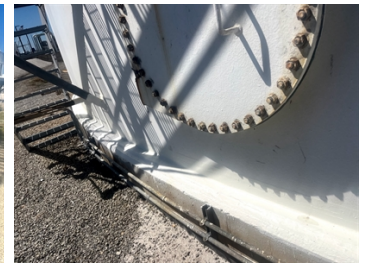
Completed coating with Belzona 3111, forming a seamless and durable barrier against water ingress. An effective and aesthetic protection to extend the asset's service life.
