Belzona Gives Better Protection on External Lining of Water Well Pump

Industry: Oil & Gas
Application: CEP-Centrifugal Pumps
Substrate: Carbon steel
Products: Belzona 5821

Customer Location: RAS LAFFAN INDUSTRIAL CITY, QATAR
Application Date: September 2022

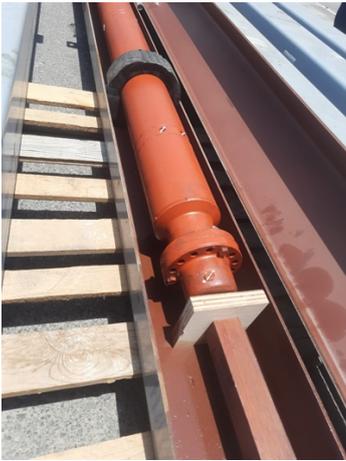
The newly fabricated well pump coated with red epoxy primer.

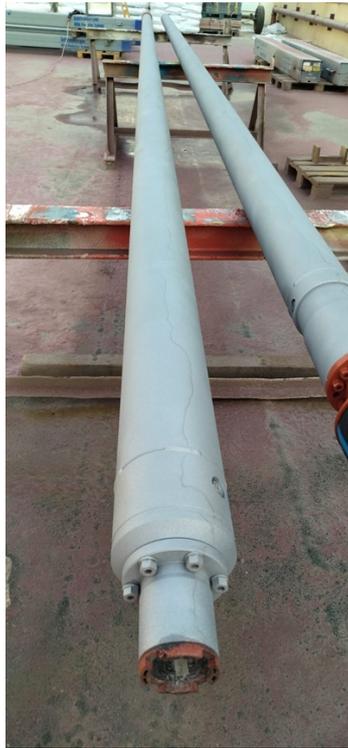
Using vapour blasting, the epoxy primer is being removed and metal surface was exposed.

1. The water well pump was initially blasted in accordance with Belzona guidelines of Surface Preparation procedure written in the IFU (Instructions for Use) which is to provide a required Cleanliness Standard of SA 2.5 with a minimum of 75 microns surface profile.
2. Belzona 5821 coating application was done in accordance with System Leaflet CEP-4 provided with an approved method statement. The coating was applied by manual application by stiff bristled brush in a thin layer per coat with maximum thickness of 150 microns only to maintain the smoothness of the coating being applied preventing it from sags occurrence.
3. Three-coat system was done to achieve the required thickness of minimum 400 microns but not more than 500 microns.

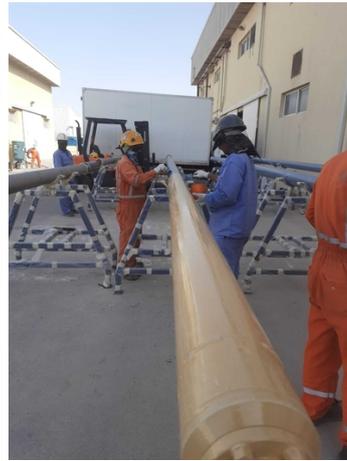
Belzona 5821 coating application was done in 3 coat system to achieve the required thickness of 400-500 microns.

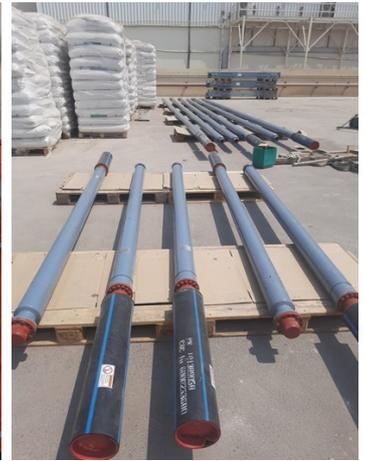
Belzona 5821 application was completed with a final coat in slate grey.
