Repairs to flats balconies and walkways

ID: 9798

Application: FPA-Floor Problem Areas

Substrate: Masonry

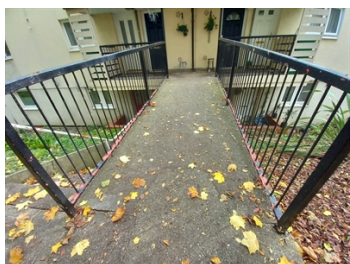
After being approached on a safety issue, Belzona were asked to supply a solution to make good spalled concrete areas and provide a safe walkway to a number of flats in the Nottingham area

Balcony before application

All concrete repairs were prepared according to IFU and System Leaflet WPA4

Application to all damaged areas using Belzona 4911 and Belzona 4141

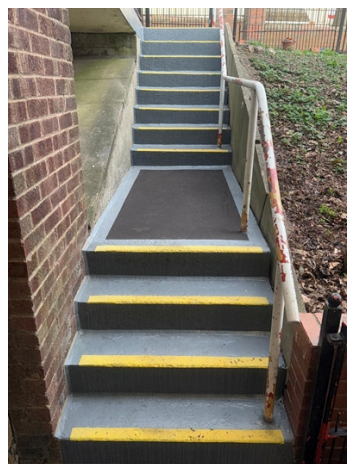
Stairs after application

Belzona 3131 was applied to the walkways and stairs using Granogrip, blinded into the second coat to offer a full grip system
