# Repairs to flats balconies and walkways

**Industry:** Buildings & Structures  
**Application:** FPA-Floor Problem Areas  
**Substrate:** Masonry  
**Products:** Belzona 3131 (WG Membrane), Belzona 4141 (Magma-Build), Belzona 4911 (Magma TX Conditioner), Belzona 9111 (Cleaner Degreaser)

**Customer Location:** Nottingham  
**Application Date:** March 2025

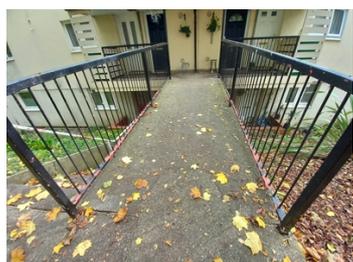
After being approached on a safety issue, Belzona were asked to supply a solution to make good spalled concrete areas and provide a safe walkway to a number of flats in the Nottingham area

Balcony before application

All concrete repairs were prepared according to IFU and System Leaflet WPA4

Application to all damaged areas using Belzona 4911 and Belzona 4141

Belzona 3131 was applied to the walkways and stairs using Granogrip, blinded into the second coat to offer a full grip system

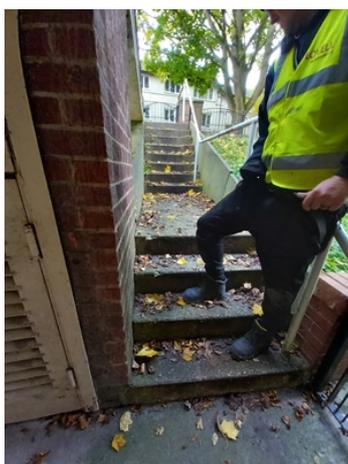
Stairs before application

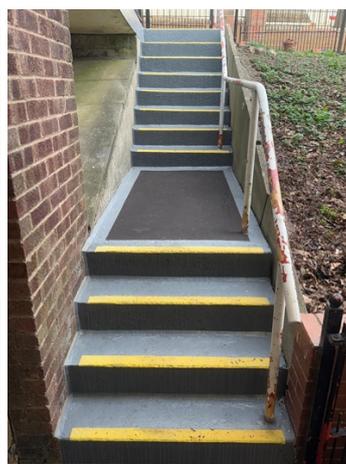
Stairs after application

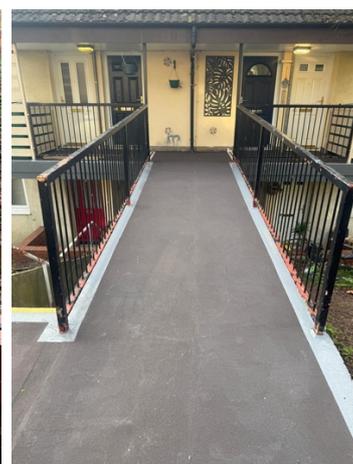
Stairs after application
