# Steel panel tanks suffering from corrosion

ID: 9799

Application: TCC-Tanks and Chemical Containment Areas

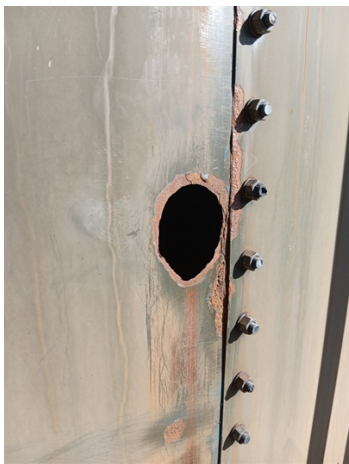
A wastewater site with typical glass-infused steel panel tanks were experiencing leaks due to internal chemical attack and environmental exposure, resulting in localised through-wall defects and seam failures.

Through wall defects from internal chemical attack and environmental exposure

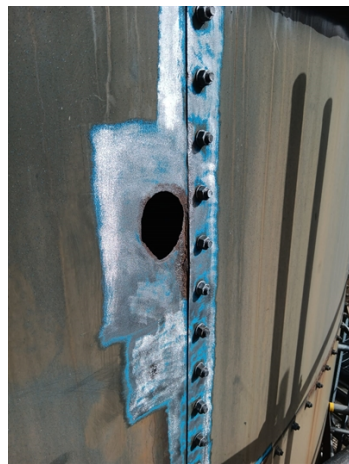
Surface area cleaned and prepared to minimum surface profile

To restore integrity, all identified areas were thoroughly cleaned and prepared before cold bonding Belzona SuperWrap II composite plates to all defects using Belzona 1111.

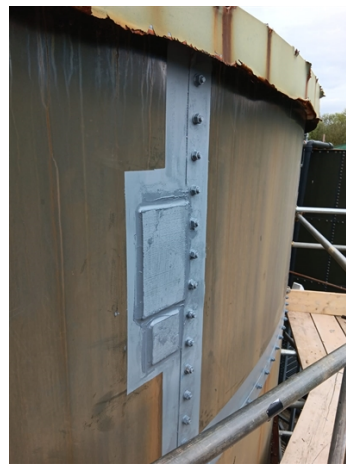
Composite plate bonded with Belzona 1111

Belzona 1111 was also applied to areas of concern along the seam lines to bring back to their original profile.

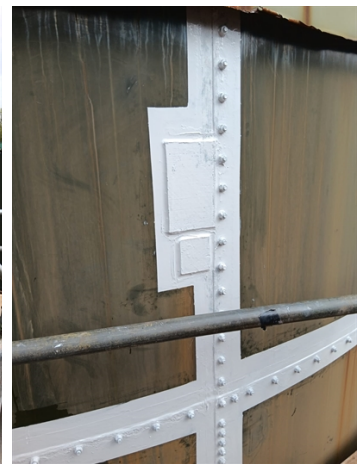
For added protection, all affected areas were then coated with Belzona 3131

For added protection, all affected areas were then coated with Belzona 3131, restoring performance and extending service life.
