# Steel panel tanks suffering from corrosion

**Industry:** Water / Wastewater  
**Application:** TCC-Tanks and Chemical Containment Areas  
**Substrate:** Other  
**Products:** Belzona 1111 (Super Metal), Belzona 3131 (WG Membrane)

**Customer Location:** Warrington  
**Application Date:** April 2025

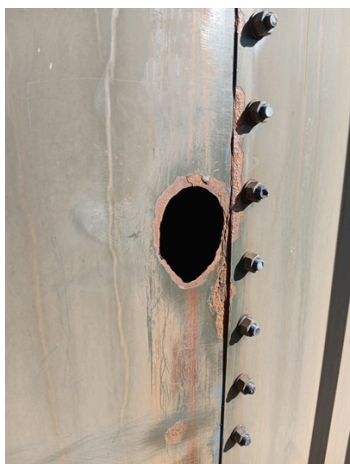
A wastewater site with typical glass-infused steel panel tanks were experiencing leaks due to internal chemical attack and environmental exposure, resulting in localised through-wall defects and seam failures.

Through wall defects from internal chemical attack and environmental exposure

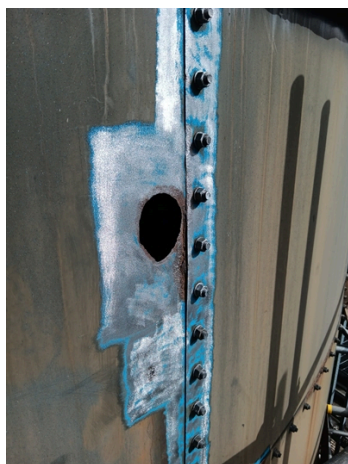
Surface area cleaned and prepared to minimum surface profile

To restore integrity, all identified areas were thoroughly cleaned and prepared before cold bonding Belzona SuperWrap II composite plates to all defects using Belzona 1111.

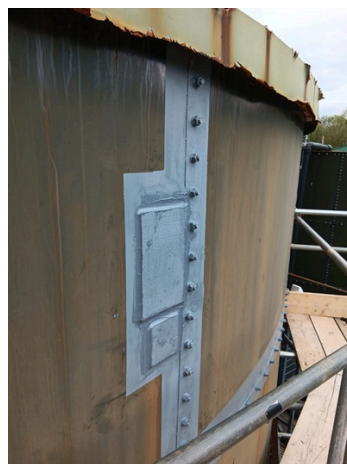
Composite plate bonded with Belzona 1111

Belzona 1111 was also applied to areas of concern along the seam lines to bring back to their original profile.

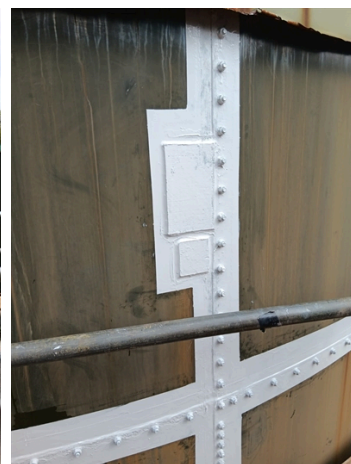
For added protection, all affected areas were then coated with Belzona 3131

For added protection, all affected areas were then coated with Belzona 3131, restoring performance and extending service life.
