IN-SITU BELZONA REPAIR TO DRYER ROLLER

ID: 98

Bearing journal on dryer roller of paper machine

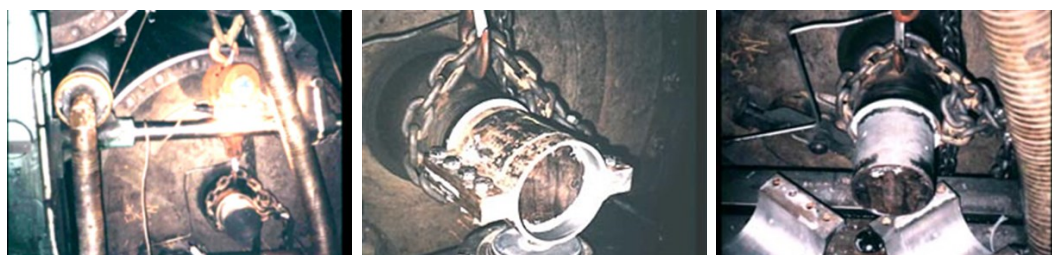
Photograph Descriptions

Collapse of bearing caused damage to the journal

- * General view of the damaged drying roller journal ,
- * Former clamped in place ,
- * Former removed showing accurately rebuilt journal ,

Application was carried out in accordance with Belzona System Leaflet MPT-2.

This application was completed in half a day whereas traditional repair would have involved dismantling of the machine and would have taken more than two days and associated loss of production. After 5 years, repair is still in service and the customer was totally satisfied.
