BELZONA HOT OFF THE PRESS

Industry: *Pulp & Paper*
Application: *SHM-Solids Handling Machinery*

Customer Location: *Regional Newspaper, Leeds, UK*
Application Date: *May 2007*

Substrate: *Rubber*
Products: *Belzona® 2311 (SR Elastomer)*

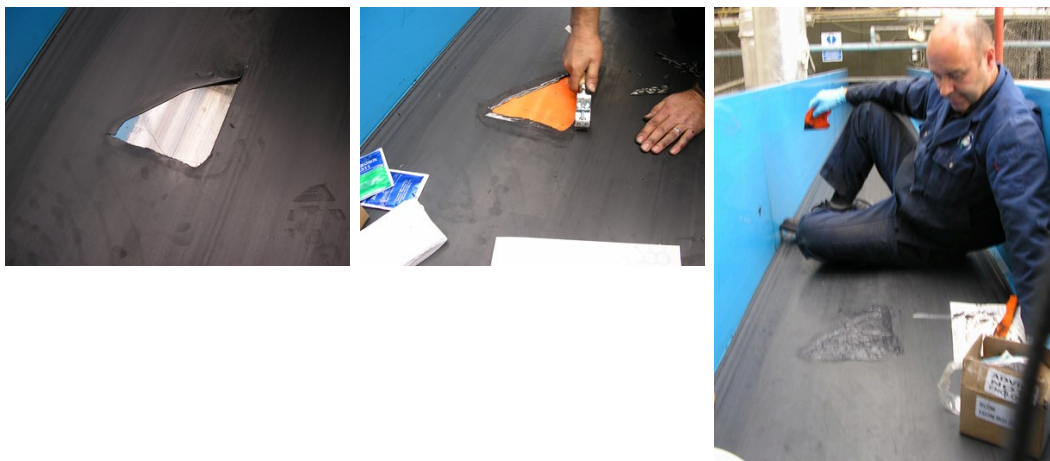
Photograph Descriptions

Large hole torn in the belt caused by a metal tool being dropped onto the belt.

* Damaged belt , * Preparation in progress , * Finished application, with customer admiring his work ,

Application was carried out in accordance with Belzona Know-How System Leaflet SHM-1.

Due to the nature of the customers business and the need for this particular belt to be running almost 24 hours a day seven days a week, it was impossible to replace the belt and would cost around £3000. Utilising the Belzona system it cost them around £40 in materials and they got the belt back up and running within 2 hours, in time for the next print run.
