Repair and coating of erosion corrosion damage on the main engine cooler cover

ID: 9800

Industry: Marine
Application: SOS-Ships and Offshore Structures

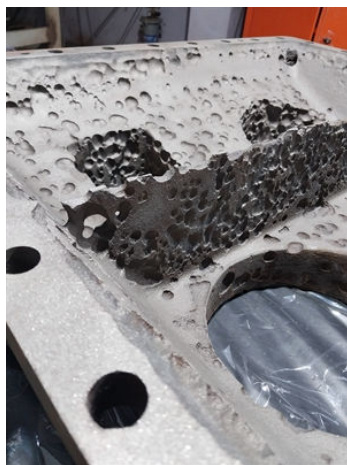
Metal losses and severe pittings occurred in the main engine cooler cover due to erosion and corrosion. The customer wanted to repair and protect the equipment with Belzona against future erosion and corrosion damage.

Severe metal losses
