Belzona SuperWrap II Repair & Reinforcement of Seawater Pipelines on LNG Ship

ID: 9801

Industry: *Marine*
Application: *SOS-Ships and Offshore Structures*

Substrate: *NAB Nickel Aluminum Bronze*
Products: *Belzona 1212, Belzona 1981 (SuperWrap II)*

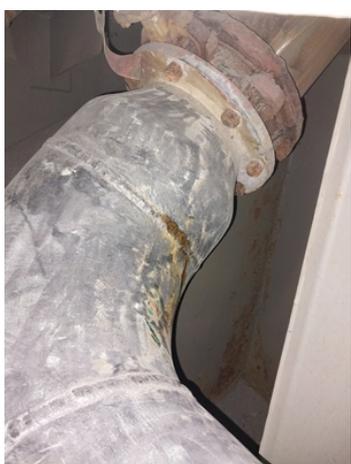
The CuNiFe seawater pipelines ranging between DN65 to DN300 on an LNG ship were weakened and leaking due to corrosion. Customer choose to repair the leaks and reinforce thinned pipelines with Belzona SuperWrap II.

Weakened and leaking areas in the pipelines.
