# Belzona Eliminates Tripping Hazards at a Medical Facility

**Industry:** Buildings & Structures  
**Application:** FPA-Floor Problem Areas  
**Substrate:** Concrete  
**Products:** Belzona 4131 (Magma-Screed), Belzona 4411 (Granogrip), Belzona 4911 (Magma TX Conditioner)

**Customer Location:** West Palm Beach  
**Application Date:** March 2025

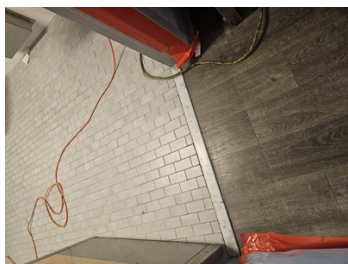
An uncomfortable step was creating serious problems on the transition from rooms to bathrooms at a healthcare facility. The patients were tripping at a serious pace. Belzona came to the rescue.

Existing transition from room to bathroom.

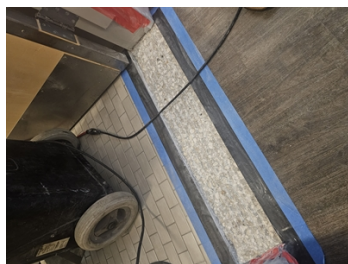
Removal of tripping hazard and surface preparation.

Application was carried out in accordance with Belzona System Leaflet FPA-1. After removing existing tripping hazard and excavating to create a solid foundation, Belzona 4131 was used to fill the space. Then, Belzona 4411 was used to complete a smooth transition.

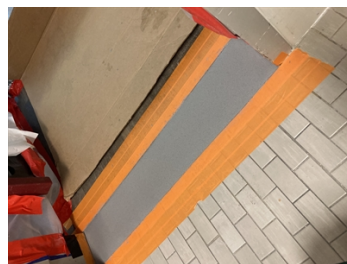
A new transition created with Belzona 4131.

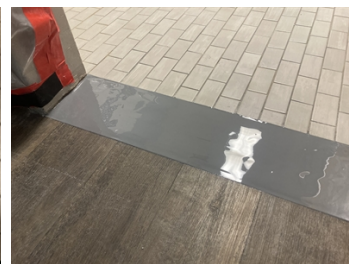
Belzona 4411 applied as topcoat.
