Belzona Eliminates Tripping Hazards at a Medical Facility

ID: 9804

Industry: Buildings & Structures
Application: FPA-Floor Problem Areas
Substrate: Concrete
Products: Belzona 4131 (Magma-Screed), Belzona 4411 (Granogrip), Belzona 4911 (Magma TX Conditioner)

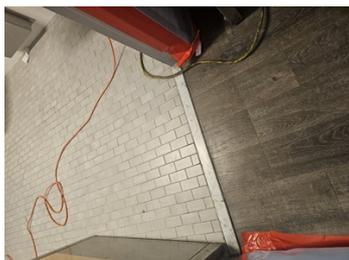
An uncomfortable step was creating serious problems on the transition from rooms to bathrooms at a healthcare facility. The patients were tripping at a serious pace. Belzona came to the rescue.

Existing transition from room to bathroom.

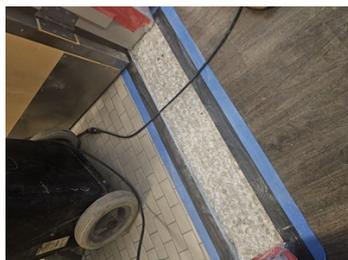
Removal of tripping hazard and surface preparation.

Application was carried out in accordance with Belzona System Leaflet FPA-1. After removing existing tripping hazard and excavating to create a solid foundation, Belzona 4131 was used to fill the space. Then, Belzona 4411 was used to complete a smooth transition.

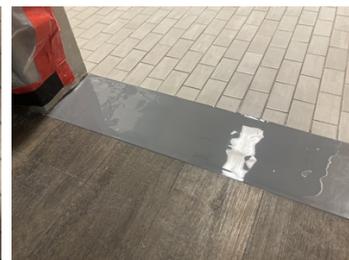
Belzona 4411 applied as topcoat.
