Belzona rescues an air handler unit over the weekend

ID: 9805

Application: HEX-Heat Exchangers

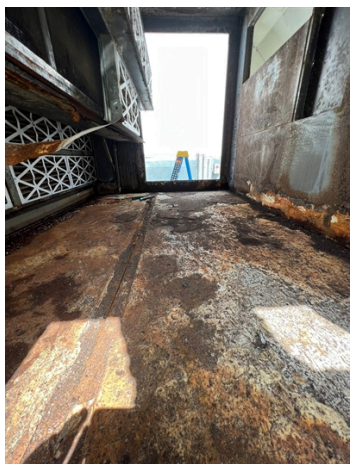
The internal surfaces of the air handler suffered from heavy corrosion due to lack of maintenance and poor performance coatings. Corroded section required removal, new metal was bonded and protective coating was applied to extend the life.

Air handler unit condition before Belzona treatment

The units was severely corroded to the point of significant metal loss. The rust needed to be removed, new metal was bonded, and coating was required to protect and extend the life of this unit.

Corrosion was removed using power tools. Most of the metal was cut out, and replaced with new metal using bonding techniques. Then, one coat of Belzona 5831 and a final coat Belzona 5811 were applied.

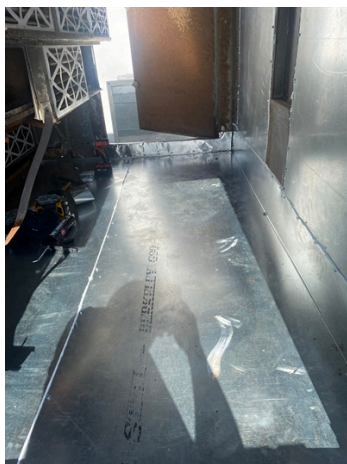
New metal was bonded using Belzona 1161

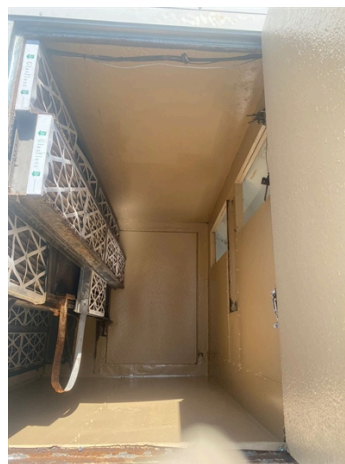
Air handler unit after application of Belzona 5831

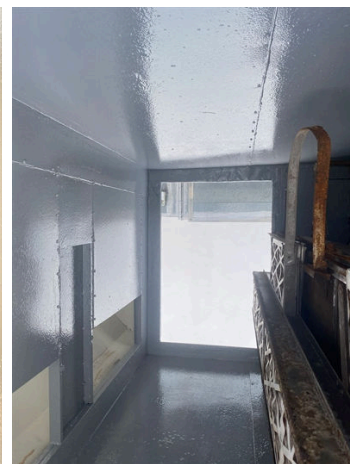
Air handler unit after application of final coat of Belzona 5811
