Belzona rescues an air handler unit over the weekend

ID: 9805

Application: HEX-Heat Exchangers

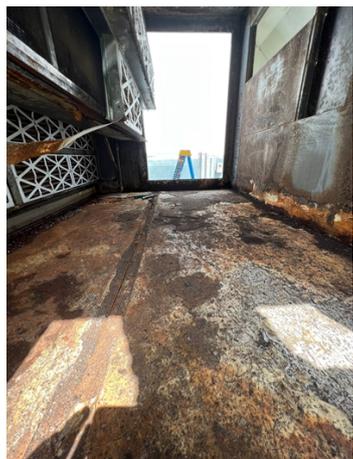
The internal surfaces of the air handler suffered from heavy corrosion due to lack of maintenance and poor performance coatings. Corroded section required removal, new metal was bonded and protective coating was applied to extend the life.

Air handler unit condition before Belzona treatment

The units were severely corroded to the point of significant metal loss. The rust needed to be removed, new metal was bonded, and coating was required to protect and extend the life of this unit.

Corrosion was removed using power tools. Most of the metal was cut out, and replaced with new metal using bonding techniques. Then, one coat of Belzona 5831 and a final coat Belzona 5811 were applied.

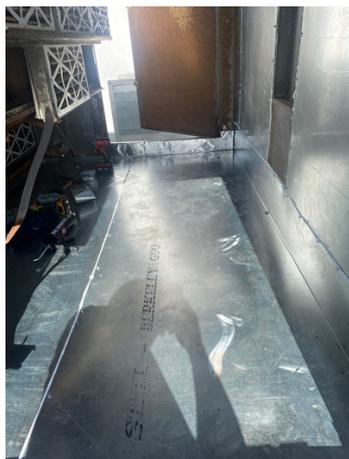
New metal was bonded using Belzona 1161

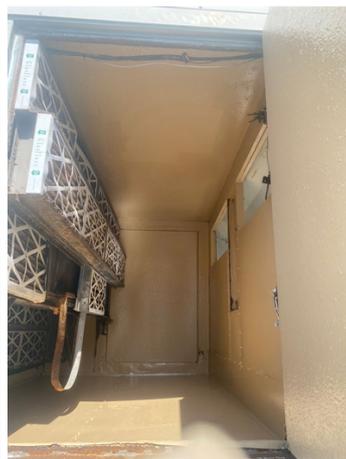
Air handler unit after application of Belzona 5831

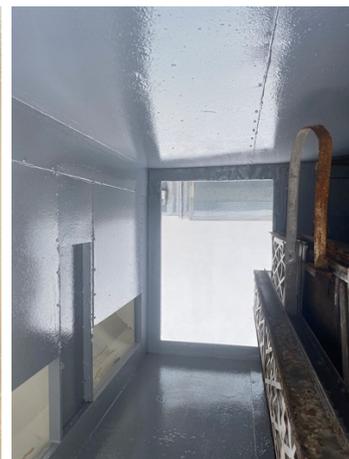
Air handler unit after application of final coat of Belzona 5811
