Repair of Small Gouges in Bearing Housing Using Belzona 1511

ID: 9806

Industry: Mining & Quarrying
Application: MPT-Mechanical Power Transmission

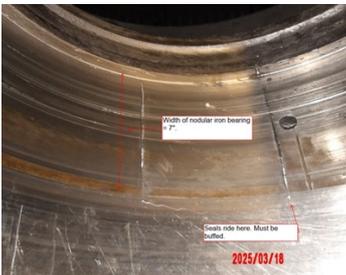
View and dimensions of some of the damaged sections

The bearing housing was first prepared by mechanically roughening the surface to remove any contamination and create a strong mechanical profile. The surface was then cleaned to eliminate dust, grease, and debris. Belzona 1511 was thoroughly mixed and applied to the gouged areas, ensuring complete filling of the voids. The material was built up beyond the final required dimensions to allow for machining. After full cure, the rebuilt areas were precision-machined to restore the original profile of the bearing housing.

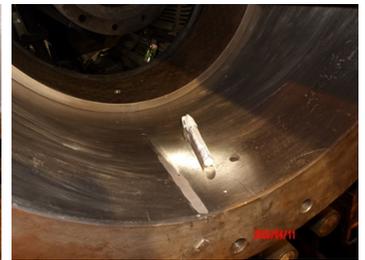
Thinner gouges filled and sanded
