# Evaporator Heat Transfer Tube

ID: 9807

**Industry:** General Industry  
**Application:** VPF-Valves, Pipes and Fittings  
**Substrate:** Carbon steel  
**Products:** Belzona 1161 (Super UW-Metal), Belzona 1984, Belzona SuperWrap II

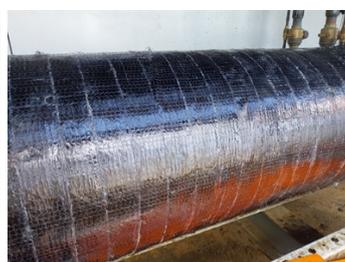
Wrapping the tube after wetting out the tube and composite wrap

Once these were cured, the tube was wetted out with Belzona 1984, as was the composite sheets

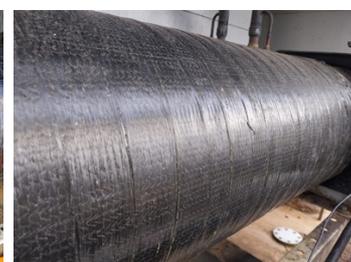
Wrap completed

2 wraps were considered enough for this application and all works were carried out in under 3 hours
