BELZONA RESTORES SCHOOL TOWER

ID: 981

Customer Location: Primary School, UK
Application Date: November 2007

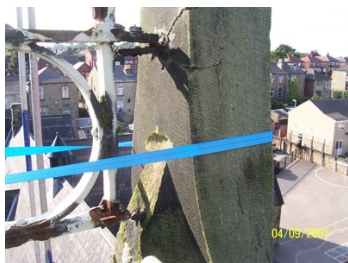
Cracking and spalling of 2 stone towers and corrosion of connecting wrought iron metalwork created a Health & Safety risk.

- * The problem ,
- * Stone removal ,
- * Completed rear tower ,
- * Completed work ,
- ,

Application was carried out in accordance with Belzona Know-How System Leaflets WPA-4 & 8. The stonework was rebuilt with Belzona® 4231. Belzona® 1111 used to rebuild corroded wrought iron before protecting with Belzona® 6111/5111 system. Belzona®
