BELZONA RESTORES SCHOOL TOWER

ID: 981

Customer Location: Primary School, UK
Application Date: November 2007

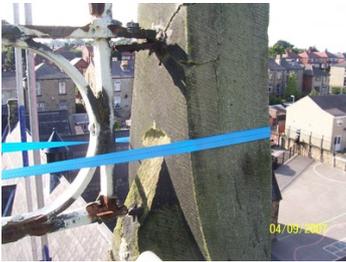
Cracking and spalling of 2 stone towers and corrosion of connecting wrought iron metalwork created a Health & Safety risk.

- * The problem ,
- * Stone removal ,
- * Completed rear tower ,
- * Completed work ,
- ,
