# Sea water pump house pipe repair

ID: 9812

Industry: *Power*  
Application: *VPF-Valves, Pipes and Fittings*  
Substrate: *Stainless-steel*  
Products: *Belzona 1111 (Super Metal)*

Customer Location: *Barrow*  
Application Date: *April 2025*

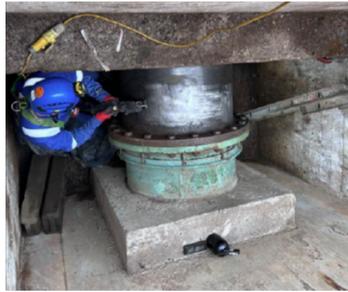
*Severe erosion - through wall defect*

Through wall defect on pipe due to severe corrosion

Surface area was prepared to minimum surface profile using power tools

Plate is bonded over the defect area and clamped in place

The entire area is wrapped with Belzona 1111 and Belzona 9341

The through wall defect area was cleaned and prepared to minimum surface profile using power tools. A pre-made plate was bonded using Belzona 1111, the surrounding surface of the pipe was then wrapped with Belzona 1111 incorporating Belzona 9341 to completely cover areas of pipe susceptible to corrosion.
