Externally corroded pipe restored and strengthened

Industry: Oil & Gas
Application: VPF-Valves, Pipes and Fittings
Substrate: Stainless-steel
Products: Belzona 1111 (Super Metal), Belzona 1981 (SuperWrap II)

Customer Location: Immingham
Application Date: April 2025

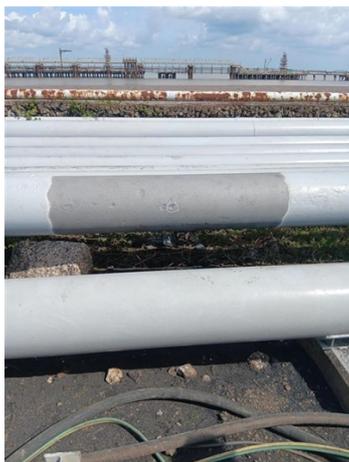
Customer identified an area of corrosion on their JP-51 pipeline, resulting in reduced wall thickness. The affected section was believed to have thinned to 5.31mm

External corrosion had caused deep pitting in the pipe

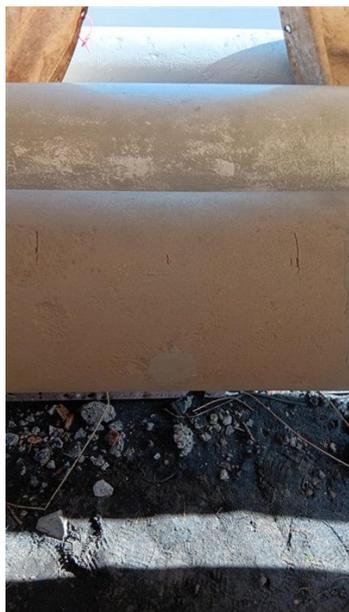
Belzona 1111 is applied to prepared surface to bring back to profile

The area was grit blasted to minimum surface profile, cleaned down and made dust free. The defect area was reprofiled using Belzona 1111 and allowed to become stable for an estimated 1 hour. Finally, our Belzona® SWII system was applied over the complete circumference area in 6 layers, before being wrapped with Belzona® 9381, consolidation tape. The following morning the consolidation tape was removed and a full inspection carried out by a Belzona supervisor.

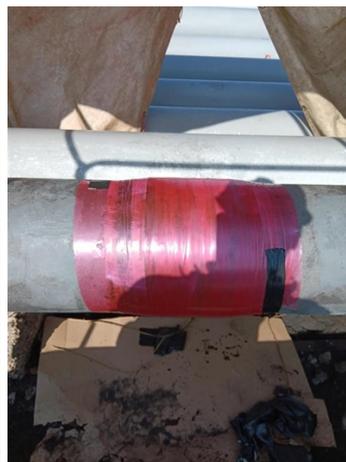
Belzona 1981 SuperWrap II system has six layers applied and consolidated with tape

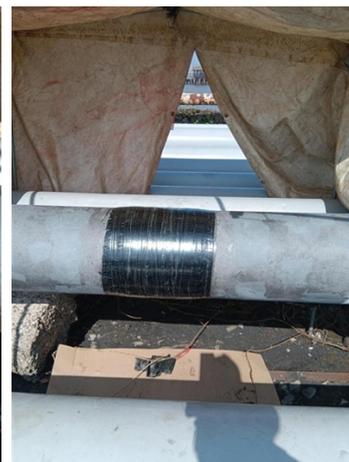
Finished application, restoring integrity and increasing strength to pipe
