# Belzona repair system to 3 x LV Bushing Flange Bases

ID: 9814

Customer Location: Kent  
Application Date: May 2025

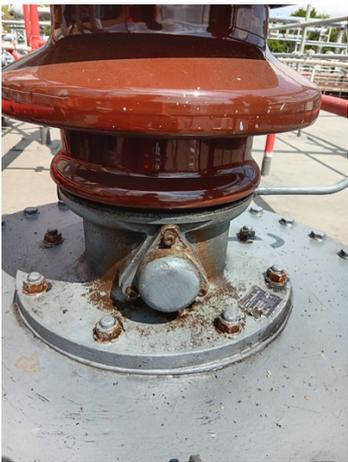
Customer identified a transformer with suspected leaks from all three LV bushing base flanges, and potentially from the porcelain interfaces.

Bushing Flange Bases had been identified as leaking oil

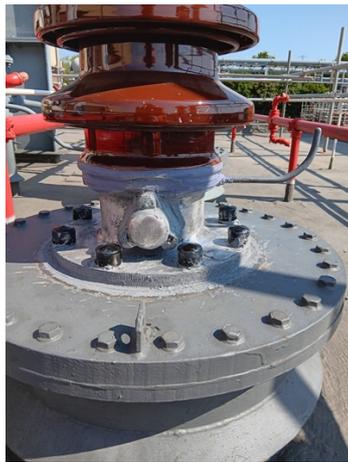
Existing paint removed and 1212 is applied

Existing paint was removed from bolts and flange areas on either side of the defect and Emery paper was used on the porcelain bases to achieve surface keying to the best possible standard.

Belzona 1212 was mixed and applied to the joint/gasket areas, as well as to the nuts and bolt heads, incorporating Belzona Reinforcement Sheet where possible. In addition, moulds filled with Belzona 1212 were placed over the bolt and nut heads, which remained in place during curing.

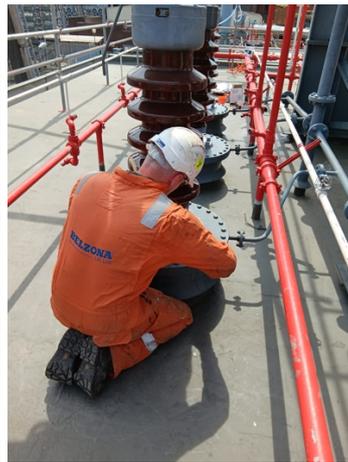
To complete application, a coating of Belzona 5831 is applied to encapsulate repair

The following day, all moulds were removed and any sharp areas carefully dressed back. To complete the system, the entire repair area will receive a final coat of Belzona 5831 LT, fully encapsulating the repair.

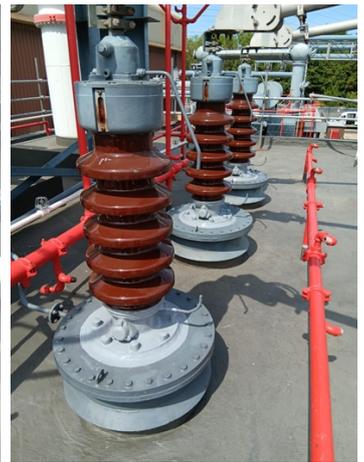
Encapsulation is complete and leak has been stemmed
