# Plate bonding on sludge tanks fixes external corrosion issue

ID: 9818

Industry: Water / Wastewater  
Application: TCC-Tanks and Chemical Containment Areas  
Substrate: Stainless-steel  
Products: Belzona 1111 (Super Metal)

Customer Location: Leamonroyd  
Application Date: April 2025

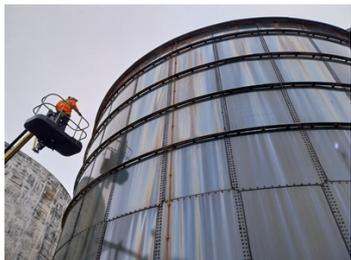
Inspection of sludge tanks to assess repair needs

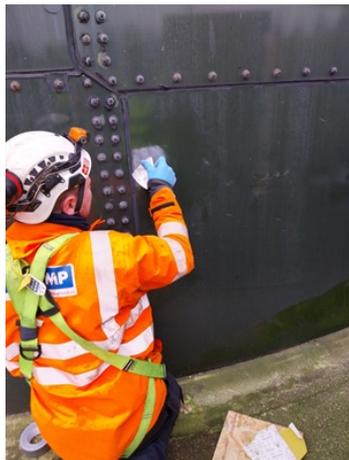
Several areas of external corrosion/damage were identified

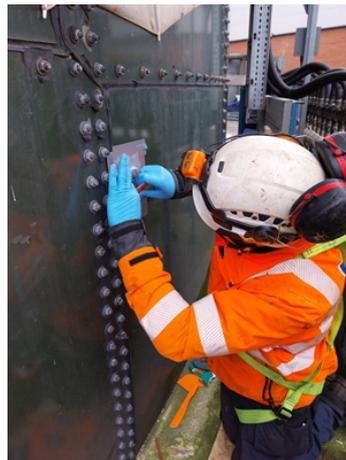
Carbon fibre plates were bonded using Belzona 1111

The surface of the tank was prepared with hand tools to minimum surface preparation. Using carbon fibre plates, the plates were bonded using Belzona 1111 to seal and ensure no further ingress of corrosion would affect the tank

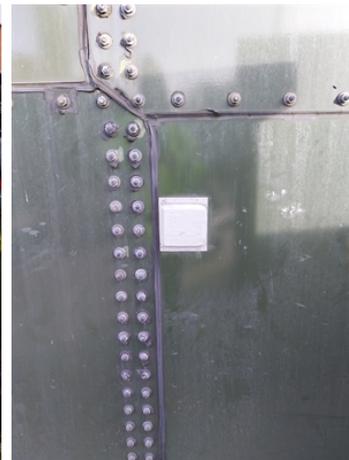
The solution ensures that no further corrosion can spread and weaken integrity of tank
