# Cool runnings with Belzona floor repairs

ID: 9821

Application: FPA-Floor Problem Areas

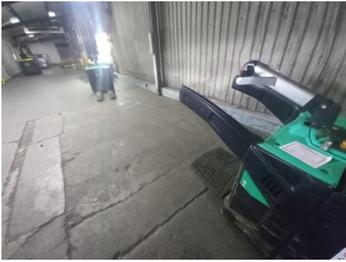
A cold storage freezer floor area was breaking up due to traffic & low temperatures. A fast back to service repair was required to be carried out over a weekend so production was not impeded.

Gaps & cracks leaving trip hazards on the floor

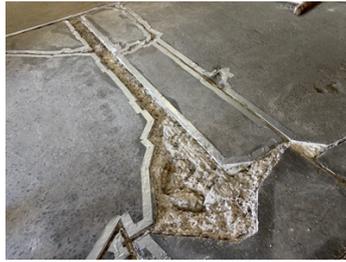
Grinding out of defective areas

The defective areas were ground out. Belzona 4911 & Belzona 4131 were then applied to level these areas. Belzona 4521 was then poured in two expansion joints where the mastic has broken up. Heaters were used to speed up the cure of the material & ensure it was ready for service.

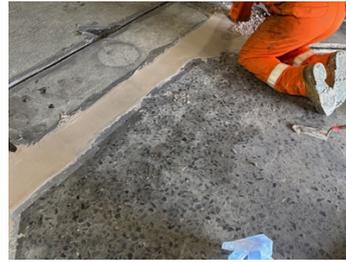
Belzona 4131 application

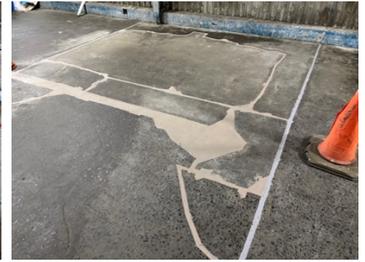
Completed Belzona 4131 areas & Belzona 4521 applied
