Forklift damage from expansion joint solved by Belzona 2211

ID: 9825

Industry: Commercial Facilities
Application: FPA-Floor Problem Areas
Substrate: Concrete
Products: Belzona 2211 (MP Hi-Build Elastomer)

Customer Location: Doncaster
Application Date: March 2025

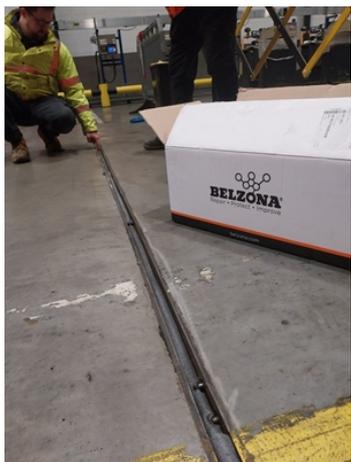
Expansion joints had separated over three decades, causing damage to forklifts operating in the area

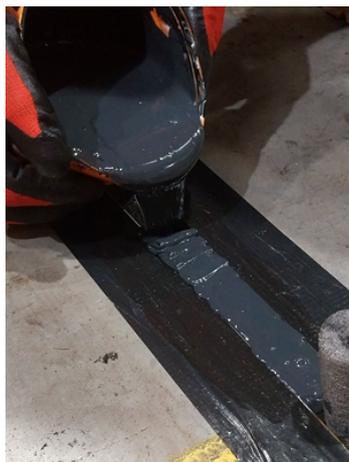
The area is suitably prepared and Belzona 2211 is then used to fill the area

All the loose and broken material from the joint was removed. Surface preparation was then performed and area conditioned. Belzona 2211(MP Hi-Build Elastomer) was installed in the expansion joint to create a flexible joint.

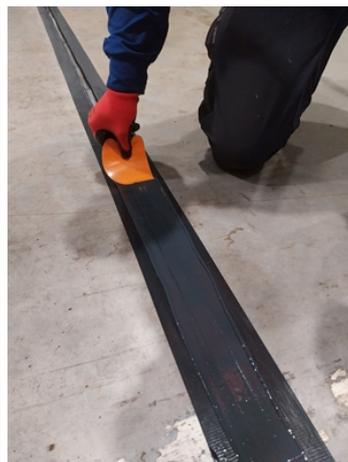
Application is completed and surface area is reprofiled

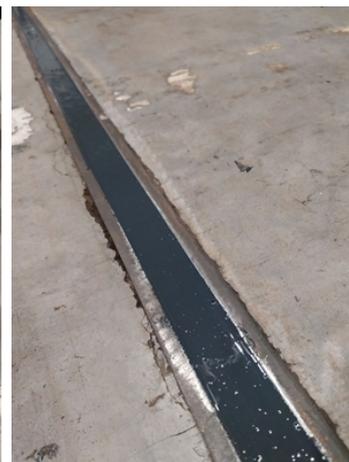
Solution is completed, sealing joint and has shown no sign of wear or deterioration protecting forklifts from damage

The joint has now been in place almost half of the year and is showing no sign of wear or deterioration, protecting the stackers and reducing damage to the machinery
