Blade Repair and Protection with Belzona 5711 and Belzona 5721

Industry: Power

Customer Location: Yai Thieng Mountain, North East Thailand

Application: FBC-Fans, Blowers and Compressors

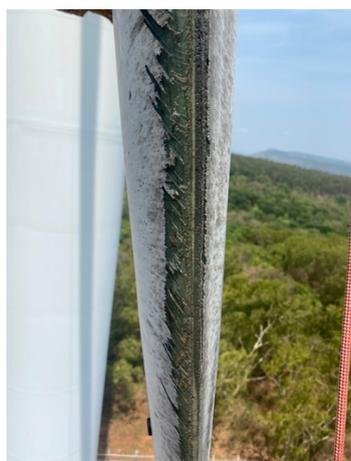
Pitting damage and coating deterioration because of rain erosion and UV attack at leading edge area.

Damage on the blade.

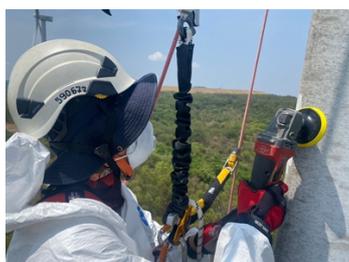
Surface preparation.

1. Sand the surface to be repaired using a coarse sander with 80-grit sandpaper, always using a new piece of sandpaper for each sanding operation.
2. Clean the surface with Belzona 9111 NF Cleaner, then allow it to dry completely.
3. Repair pitting with Belzona 5711.
4. Smooth Belzona 5711 using a coarse sander with 80-grit sandpaper.
5. Mix Belzona 5721 and apply it within 20 minutes using a high-quality brush. Apply at a wet film thickness of 500 microns and then allow it to fully cure for 5 hours at 30°C.

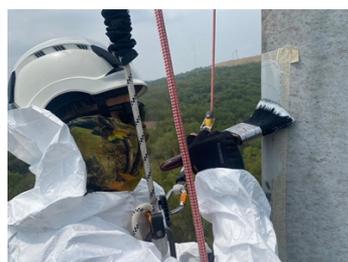
Application of Belzona 5721

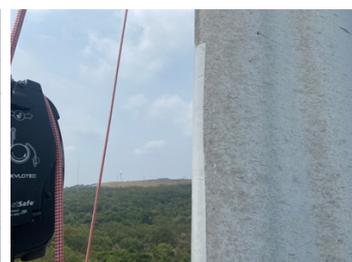
Completed application
