BELZONA LINING OF WATER TANK

ID: 983

Application: *TCC-Tanks and Chemical Containment Areas*

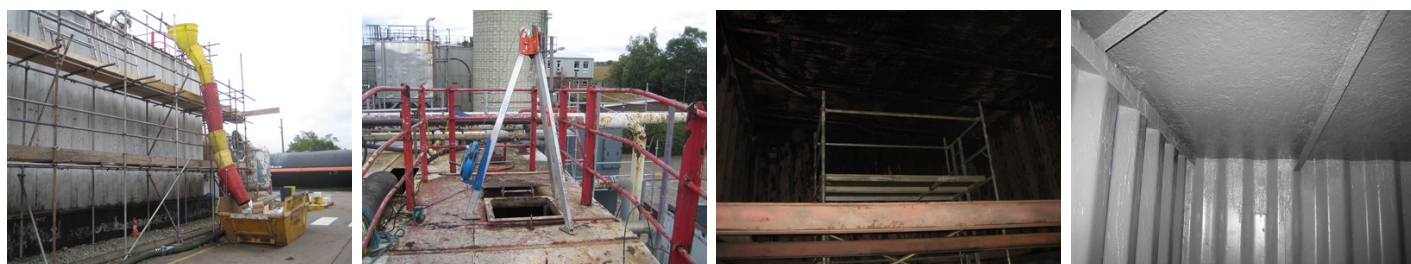
Photograph Descriptions

Over a period of years the interior lining of the tank had deteriorated to a point where it was both leaking and affecting the water quality.

* Tank showing method for disposing of waste and debris from within tank , * Top of Tank showing Hoist for vacuation of material and personnel , * Internal of Tank prior to Coating , * Internal of Tank after coating ,

Application was carried out in accordance with Belzona Know-How System Leaflet TCC-5.
