# Complete Rehabilitation of Fire Pump

ID: 9832

Application: CEP-Centrifugal Pumps

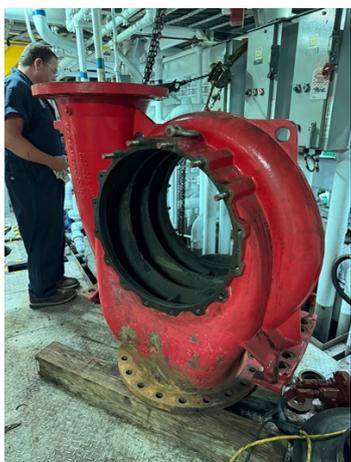
The customer was facing severe internal corrosion on their fire pump casing, with extensive material loss, flaking rust, and erosion damage. Several areas showed wall thinning and through-wall defects, compromising the structural integrity of the equipment. The pump was no longer reliable for emergency operation, posing a safety risk to the vessel.

Initial condition of the fire pump casing before repair. Severe internal corrosion, wall loss, and surface damage are visible, requiring structural rebuilding and protective coating.

The internal surfaces of the fire pump casing were blasted to ensure proper mechanical adhesion. Surface cleanliness was verified,

and Belzona 9111 was used to remove contaminants. Belzona 1121 was applied using applicator tools to rebuild areas with wall loss and restore the original geometry. After curing, two coats of Belzona 1341 were applied by brush, the first in grey and the second in blue to ensure full coverage and visual confirmation of coating integrity.

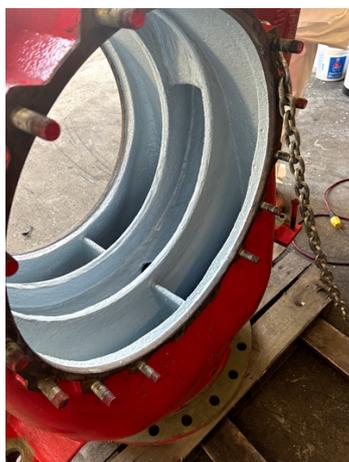
Restored fire pump casing after application of Belzona 1121 for rebuilding and two coats of Belzona 1341 for internal protection and hydraulic efficiency. The light grey topcoat indicates the completion of the first protective layer.

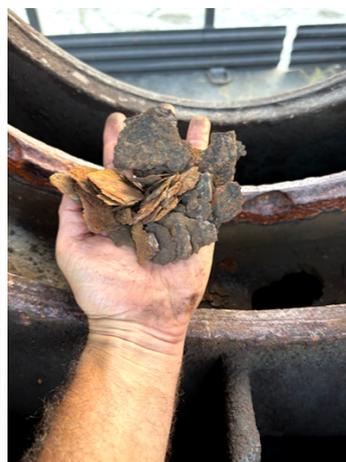
Large flakes of rust detached from the internal surfaces of the fire pump casing, highlighting the severity of corrosion and the urgent need for rehabilitation."

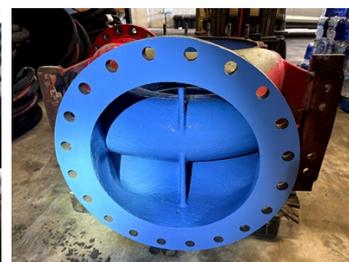
Fire pump casing fully rebuilt and coated. Final coat of Belzona 1341 Blue applied to improve hydraulic efficiency and provide long-term protection against corrosion and erosion.
