Water Tank Sprung Leak

ID: 9835

Industry: *Other*
Application: *TCC-Tanks and Chemical Containment Areas*

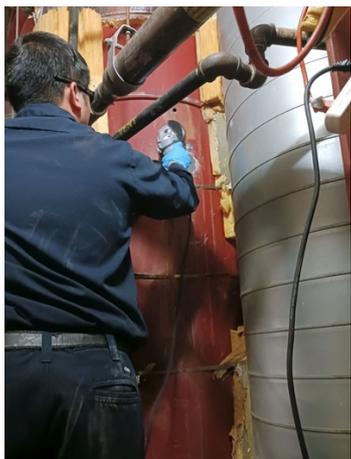
Preparation in progress at corrosion and holed area on water tank.

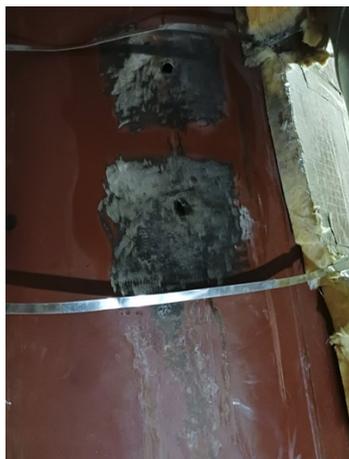
Repair areas on water tank ready for cold bonding of the new plates.

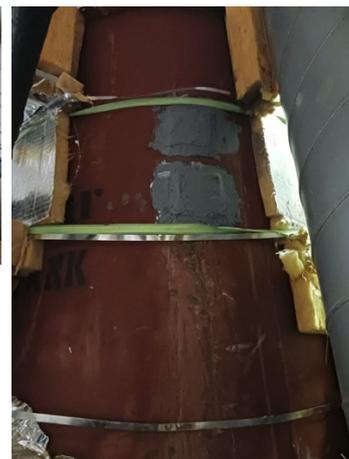
New cold bonded plates applied to tank using Belzona 1111

Method used was cold bonding new plates at repair areas, tooling used was a grinder with a 80 grit sanding disc and grinding wheel.
