In-Situ Fan Shaft Rebuild

ID: 9838

Application: *MPT-Mechanical Power Transmission*

Substrate: *Carbon steel*

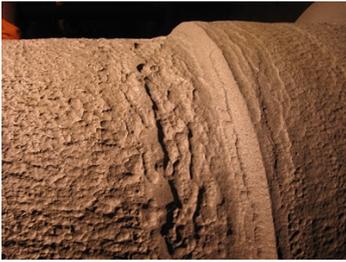
Pitting corrosion was causing balance issues. A new part was months from being procured.

Severe Pitting Corrosion

Area was grit blasted and degreased. Then Belzona 1311 was applied to the damaged areas followed by two coats of Belzona 1321.

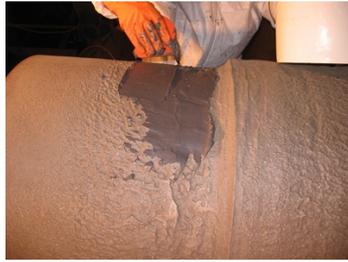
Belzona 1311 being applied to rebuild damaged areas

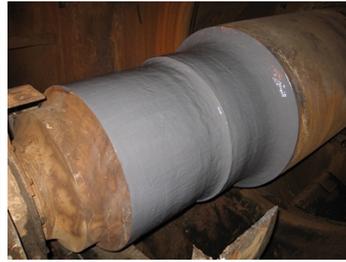
Belzona 1321 brush applied
