# In-Situ Fan Shaft Rebuild

ID: 9838

Application: *MPT-Mechanical Power Transmission*

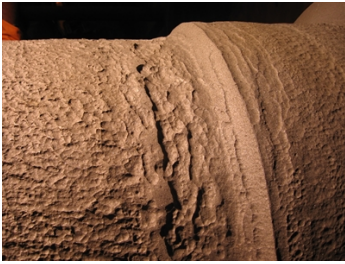
*Pitting corrosion was causing balance issues. A new part was months from being procured.*

Severe Pitting Corrosion

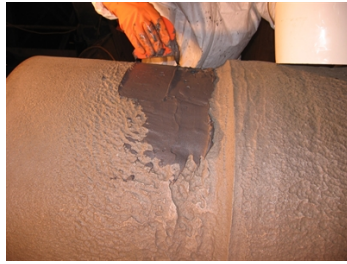
Belzona 1311 being applied to  
rebuild damaged areas

Area was grit blasted and degreased. Then Belzona 1311 was applied to the damaged areas followed by two coats of Belzona 1321.

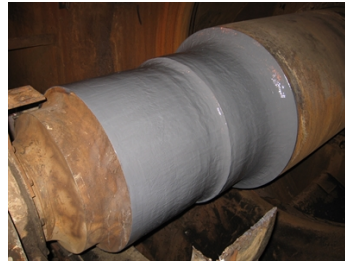
Belzona 1321 brush applied
