"DUCKS FEET" REFURBISHED WITH BELZONA

ID: 984

Customer Location: Power Station, UK
Application Date: July 2005

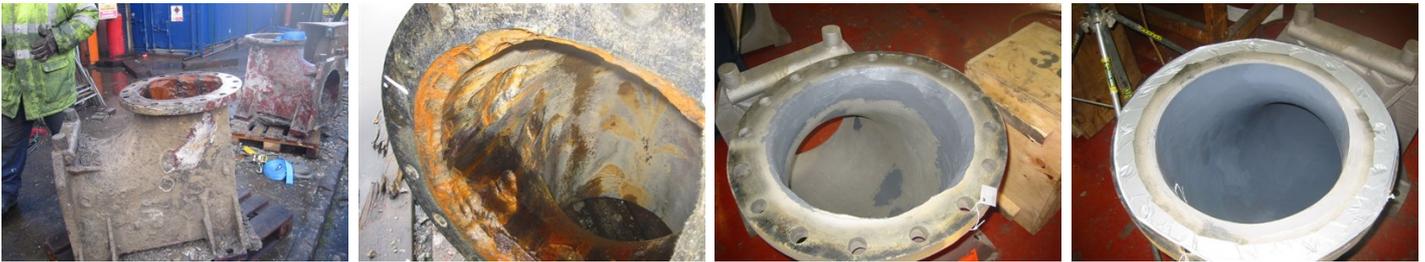
Photograph Descriptions

Severe erosion, corrosion to body. The Power Station tried to order new ones but were told the delivery was upwards of 6 months! As they were right at the end of the shutdown this was not suitable.

- * As they arrived at contractor ,
- * Internal view showing severe damage ,
- * After blasting and re-building with Belzona® 1311 ,
- * Fully coated with Belzona® 1321, looking rather better than when they arrived! ,

After 10 years in service these "ducks feet", situated at the bottom of the CW pipework, were found to be in very bad condition. There were 4 units to re-furbish.

Application was carried out in accordance with Belzona Know-How System Leaflets VPF-1 and -2. Substrate was washed and blasted several times to remove salts and to provide correct surface for application. The badly eroded areas were re-built with Belzona® 1311 and then each was given 2 coats of Belzona® 1321.
