Sealing around welded pipework entry for chemical tank

ID: 9850

Application: TCC-Tanks and Chemical Containment Areas

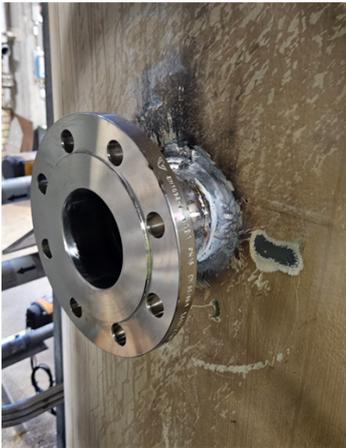
The new pipework is welded and in place

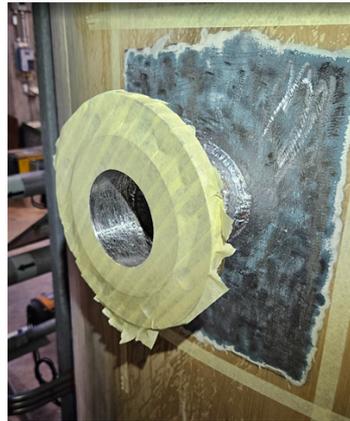
Masked edges and mechanical surface preparation

Mechanical surface preparation, Trowelling with Belzona 1161 on the new weld and transition, then 2 coats of Belzona 1391T

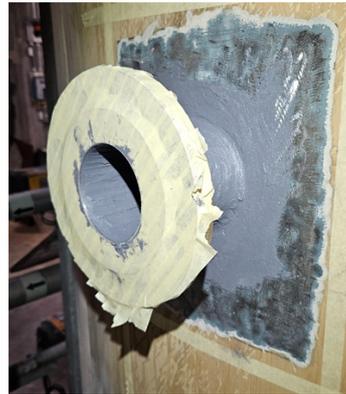
Grouted surfaces with Belzona 1161 to seal around the new weld

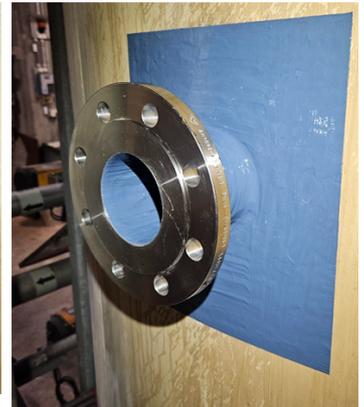
Finished result with two coats of Belzona 1391T
