# Belzona Shaft Repair on Commercial Mixer in Food Production Facility

ID: 9851

Application: MPT-Mechanical Power Transmission

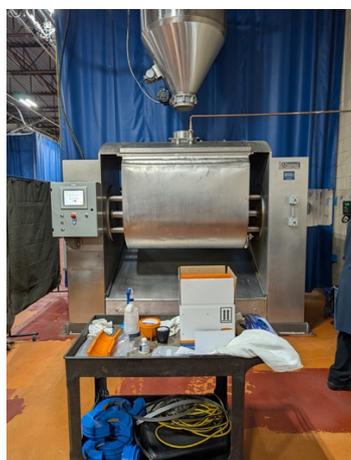
The Client, operating a Food Production facility in Mississauga, Ontario. Had a large scale, horizontal mixer experiencing advanced wear on several output shafts. Subsequently, the mechanical seals were unable to perform due to the damage, causing both product leakage and potential contamination. The equipment was a piece of legacy hardware that had previously been retrofitted and repaired using an unknown product.

Showcasing the piece of equipment

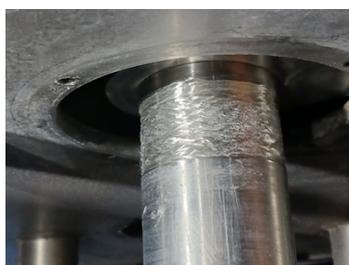
Completed surface prep of the damaged area

Surface prep was completed using a combination of Sanding Strips, Grinders, and Manual Filing tools.

The area was then taped off to prevent excess product from curing on the unaffected shaft areas.

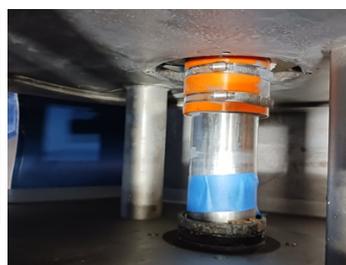
Repaired area using the Forming technique

This repair was completed using a custom printed 3D mold, coated with Belzona 9411 Release Agent

The Molds were then used in conjunction with Belzona 1311 to complete the repair using the proper Forming Technique.

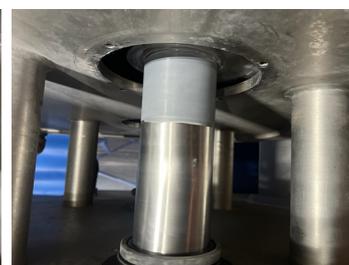
Completed repair area
