## Belzona saves Chopper pumps destined for the scrapyard

ID: 9856

Industry: Water / Wastewater  
 Application: CEP-Centrifugal Pumps  
 Substrate: Cast Iron  
 Products: Belzona 1321 (Ceramic S-Metal)

Customer Location: West Midlands, England  
 Application Date: January 2023

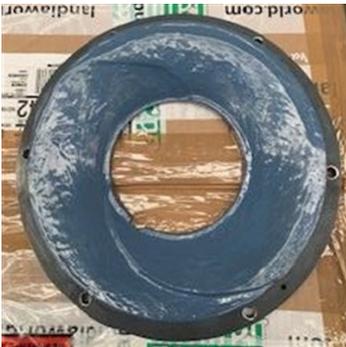
Wear plate being coated

The Customer free issued new wear components consisting of Front wear plate, Back wear plate and Volute casing, Grit blasted new components to achieve correct surface profile in line with SA2.5 Applied Belzona 1321 Abrasive Resistant coating.

Gritblasted to SA Standard  
 Coated with Belzona 1321

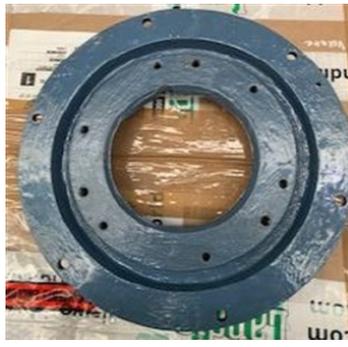
Wear plate being coated

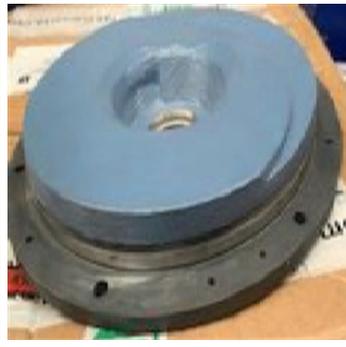
Wear plate being coated

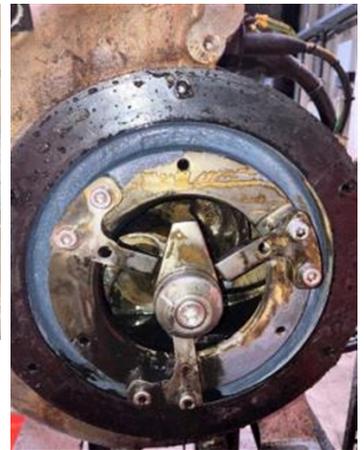
After 6 months being in service

The service and inspection were carried out last week with success. We have saved the parts in between servicing and they will last until the next service. Doubling the life of the parts!!!
