# Lightweight Belzona makes Rope Access a competitive option

ID: 9858

Industry: Buildings & Structures

Application: WPA-Wall Problem Areas

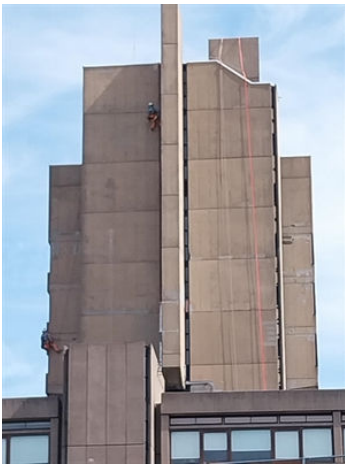
General view of the West face of the building, showing IRATA L3 Rope access engineers carrying out repair works with Belzona 4911 and Belzona 4141

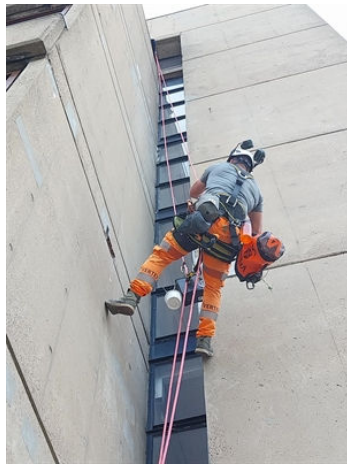
IRATA L3 Engineers able to carry out more repairs with less returns to base, thanks to the incredibly lightweight properties of Belzona 4141

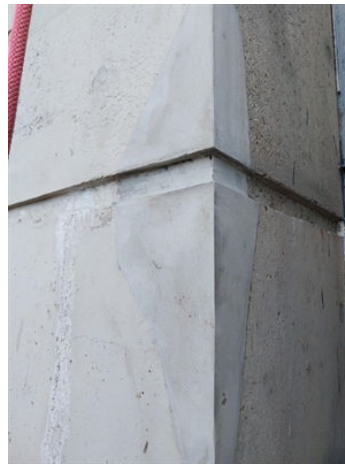
Repairs to vertical sections of the walls

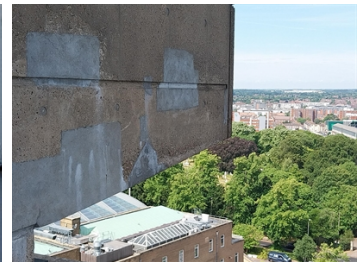
Repairs to vertical wall, combined with overhead repairs.
