BELZONA REPAIRS HOLED NOZZLE ON GLYCOL PLANT

ID: 986

Customer Location: Gas Processing Plant, UK

Application: VPF-Valves, Pipes and Fittings

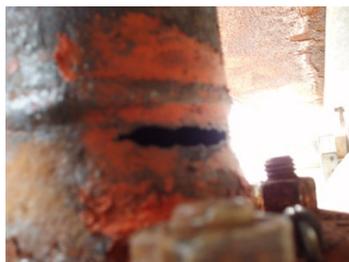
Corrosion had caused severe wastage of a nozzle which resulted in two holes breaking through.

* View of plant area , * View of one of the two holes in the nozzle , * View of the plates prior to bonding , * View after the plate bond and wrap was completed ,

Corroded and holed 3 inch diameter nozzle

Application was carried out in accordance with Belzona Know-How System Leflet VPF-11a. Plates were tailor made on site to completely encapsulate the nozzle. Once bonded, the whole nozzle was also wrapped.
