Belzona improves the durability of a brand new Screw Conveyor loader trough

ID: 9860

Application: SHM-Solids Handling Machinery

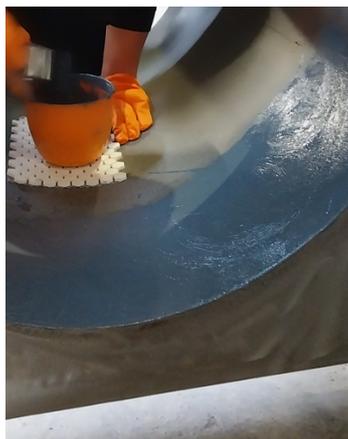
"Wetting out" the blasted substrate using Belzona 1321 as the adhesive.

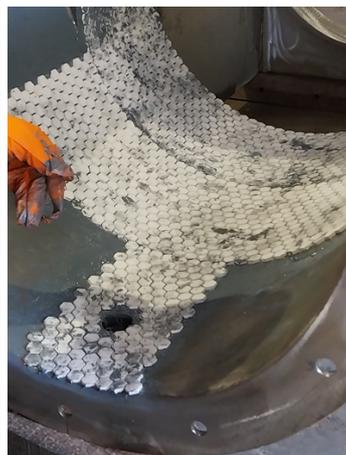
Applying the Belzona 9811 alumina tiles to a 600 micron coat of Belzona 1321, following wetting out.

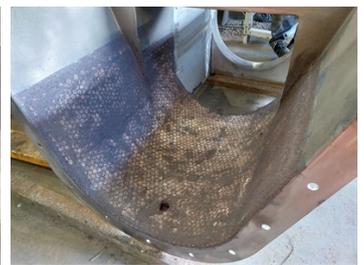
Once the Belzona 1321 had cured, Belzona 1812 was used to "grout" the tiles and interfaces of the Belzona 9811 Alumina tiles, leaving a fully protected surface to the filler trough.
