Belzona Repairs Prior Coating Failure and Cavitation Issues with Transducer

Application: SOS-Ships and Offshore Structures

Products: Belzona 1111 (Super Metal), Belzona 1121 (Super XL-Metal), Belzona 1161 (Super UW-Metal)

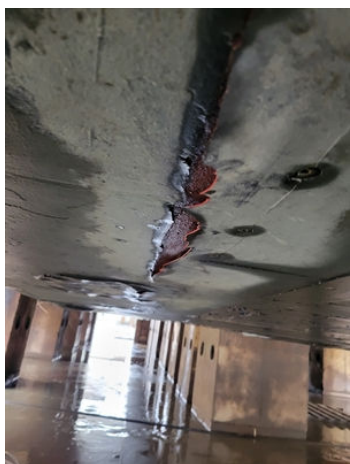
There were cavitation and Coating Failure issues on the underside of a Transducer of an Exploration Vessel, and they needed a quick turn-around to get back out to sea.

Failure of the previous coating due to cavitation and adhesion issues.

There were some coating and cavitation issues on the underside of a Transducer that is used to "map" the Ocean Floor and provide geological data. Belzona 1161, 1111, and 1121 to fill in areas where there was damage and shallow pitting or cavitation. Belzona was the best option under the circumstances of where the damage was, and the expense of damaging the transducer using other means. Belzona saved the client money and time to get back out to sea.

Surface Preparation: The damaged areas were cleaned and prepared by sanding and lite grinding to ensure maximum adhesion of the Belzona materials. This included removing any loose debris, contaminants, and preparing the surface for the composite.

Application of Belzona 1111 and 1161: The Belzona composite products were applied to the damaged areas. Its excellent bonding properties allowed it to adhere firmly to the prepared surface, effectively filling and covering the damaged surfaces

Application of Belzona 1121: Once the Belzona 1161 cured, Belzona 1121 was applied to provide an additional layer of protection, ensuring the repaired areas would withstand future exposure to water and corrosion.

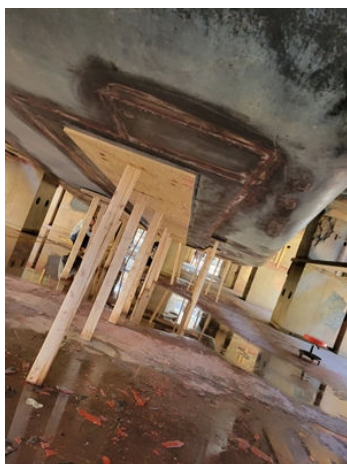
Support for padding used to protect the transducer and transmitters.

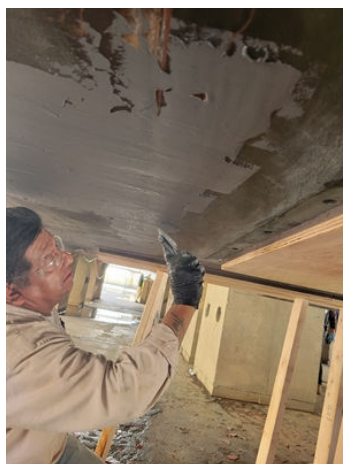
Application in progress.

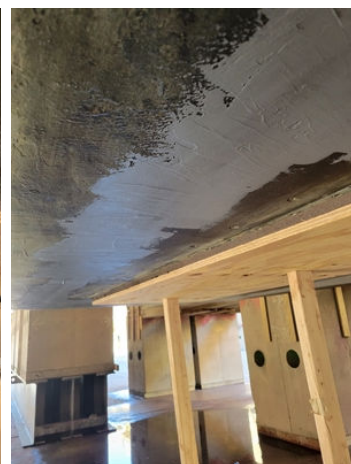
Application completed.
