# Belzona Repairs Prior Coating Failure and Cavitation Issues with Transducer

ID: 9861

Industry: Marine  
Application: SOS-Ships and Offshore Structures

Substrate: Carbon steel  
Products: Belzona 1111 (Super Metal), Belzona 1121 (Super XL-Metal), Belzona 1161 (Super UW-Metal)

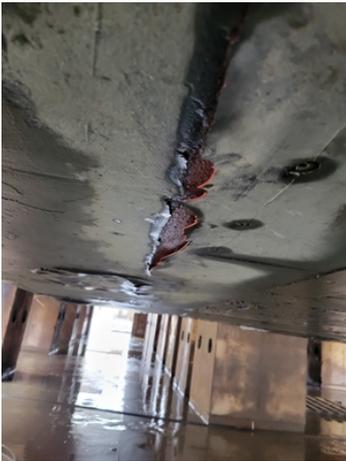
Failure of the previous coating due to cavitation and adhesion issues.

Surface Preparation: The damaged areas were cleaned and prepared by sanding and lite grinding to ensure maximum adhesion of the Belzona materials. This included removing any loose debris, contaminants, and preparing the surface for the composite.

Application of Belzona 1111 and 1161: The Belzona composite products were applied to the damaged areas. Its excellent bonding properties allowed it to adhere firmly to the prepared surface, effectively filling and covering the damaged surfaces

Application of Belzona 1121: Once the Belzona 1161 cured, Belzona 1121 was applied to provide an additional layer of protection, ensuring the repaired areas would withstand future exposure to water and corrosion.

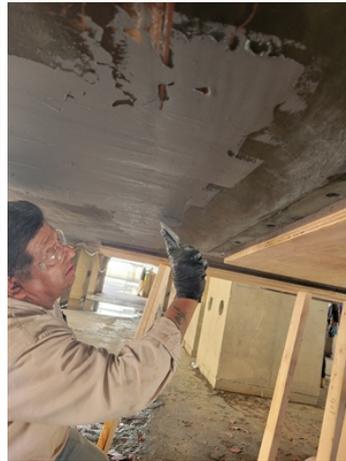
Application in progress.

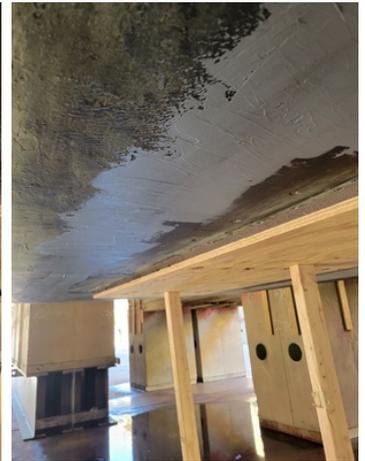
Application completed.
